**Coal Combustion Waste Impoundment
Round 5 - Dam Assessment Report**

Winyah Generating Station (Site #004)

**Santee Cooper
Georgetown, South Carolina**

Under Contract Number: EP-09W001727
January 2011

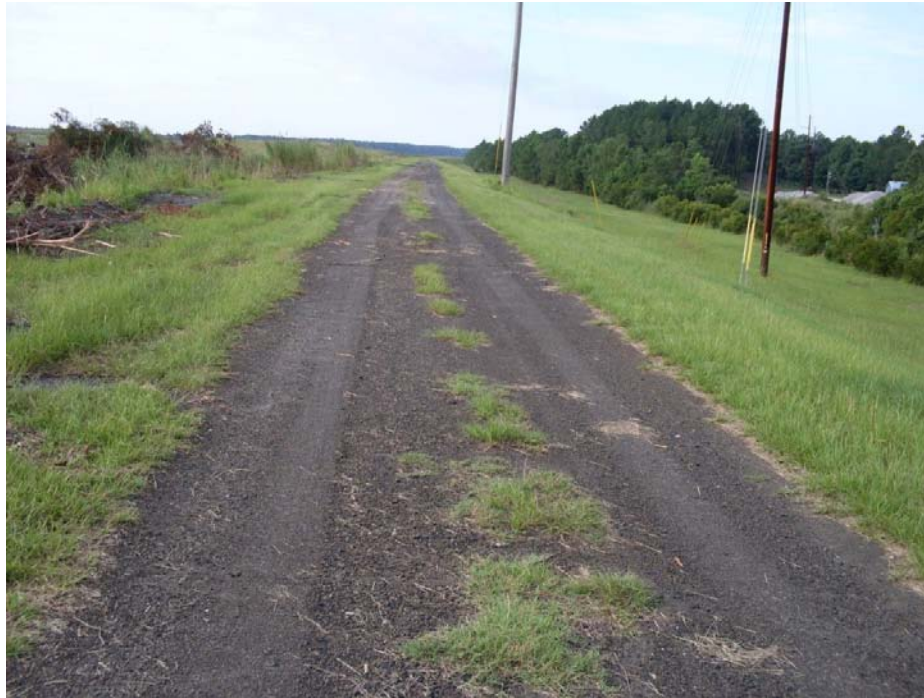
Photo BA-1: Crest of Perimeter Dike West Side of Pond A near Northwest Corner – Viewed South

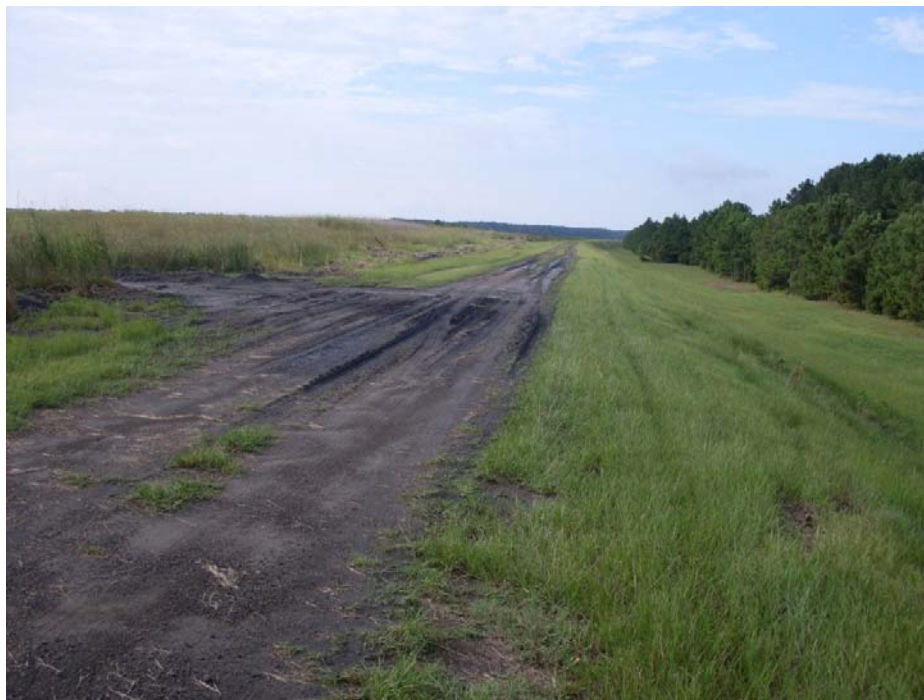
Photo BA-2: Crest of Perimeter Dike at Ash Removal Equipment Access on Ash Pond A – Viewed South.

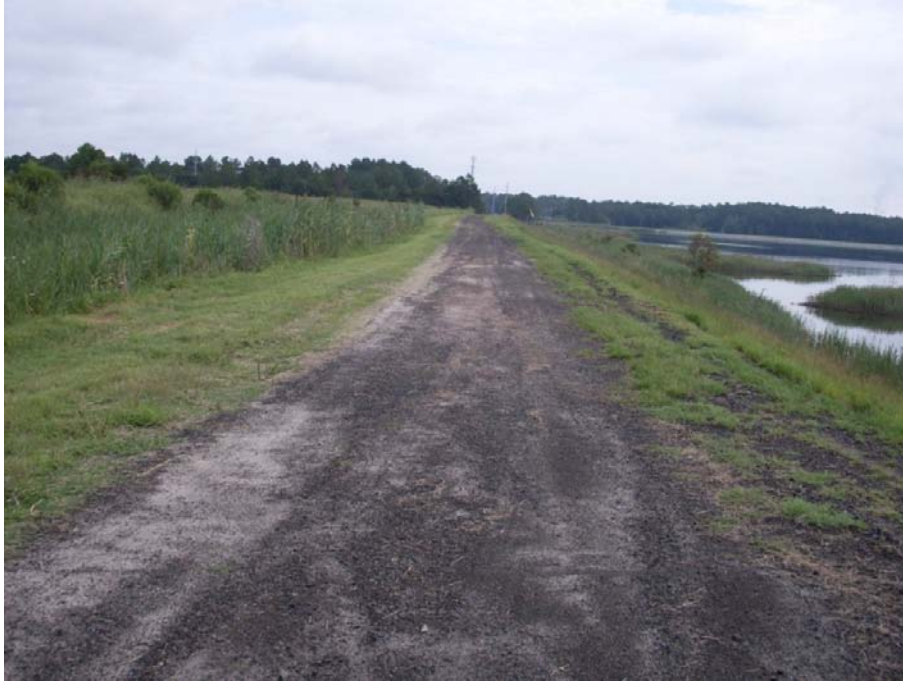
Photo BA-3: Crest of Perimeter Dike East Side of Pond A Near Cross Dike Intersection – Viewed North.

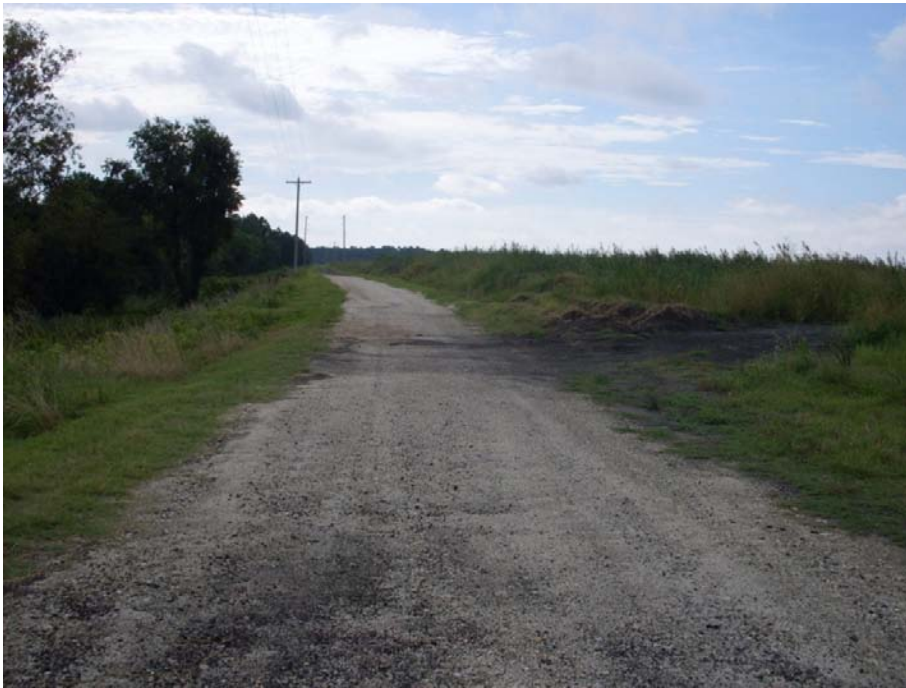
Photo BA-4: Crest of Perimeter Dike North Side of Ash Pond A near Northwest Corner – Viewed East.

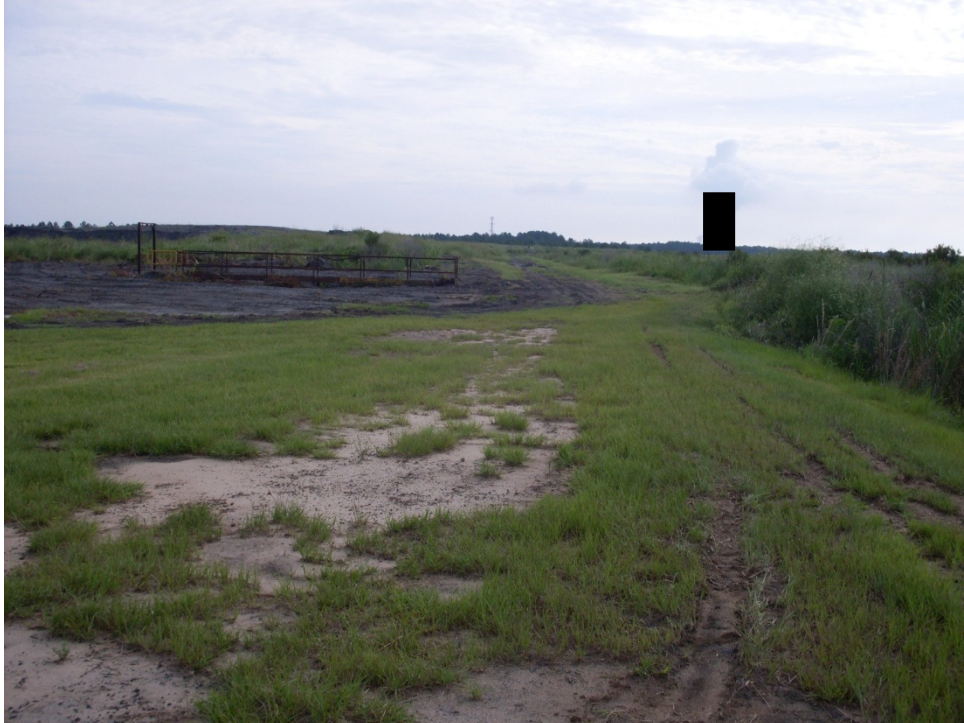
Photo BA-5: Crest of Cross Dike and Walkway to Abandoned Decant Tower and Drainline from Ash Pond A to Ash Pond B – Viewed Northeast.

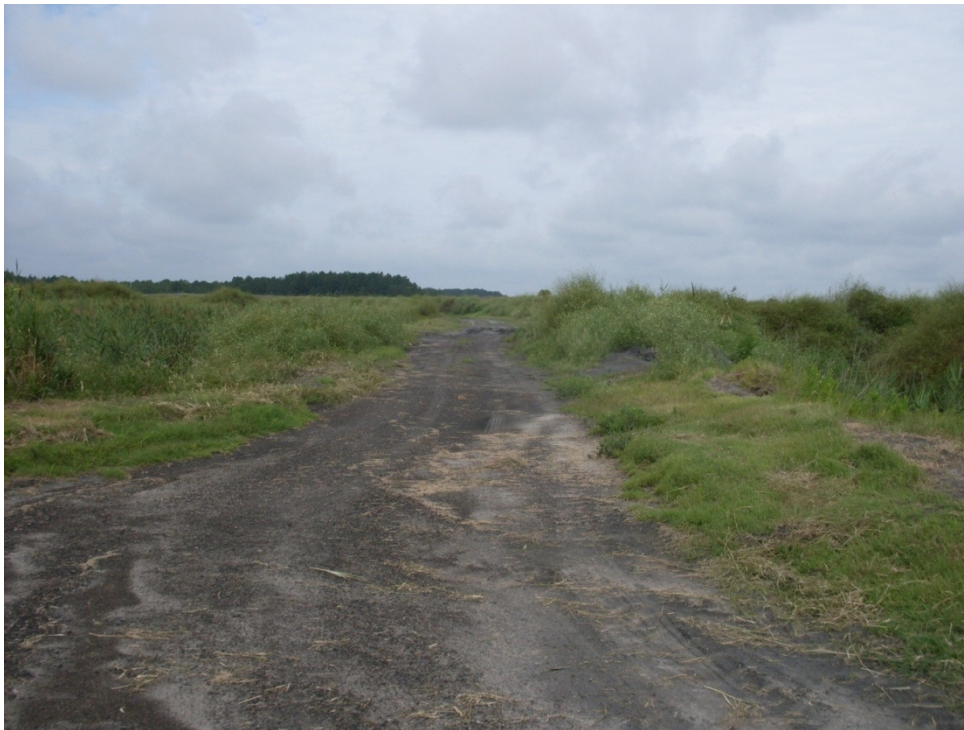
Photo BA-6: Crest of Cross Dike Between Ash Pond B and Ash Pond A – Viewed Southwest.

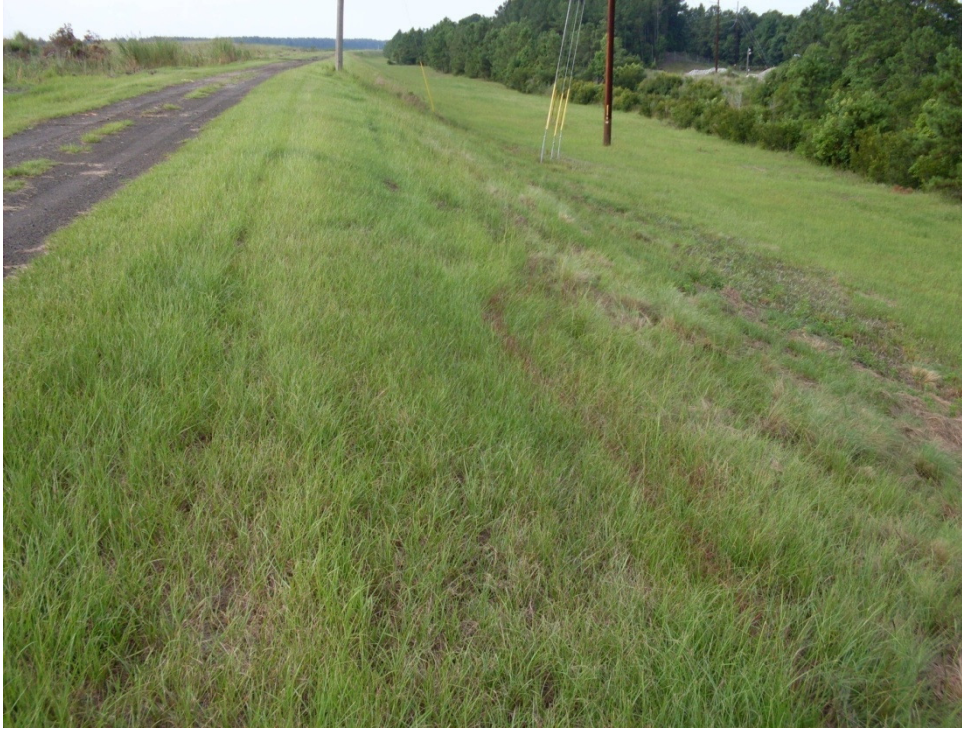
Photo BA-7: Outside Slope of Perimeter Dike at Northwest Corner of Ash Pond A – Viewed South.

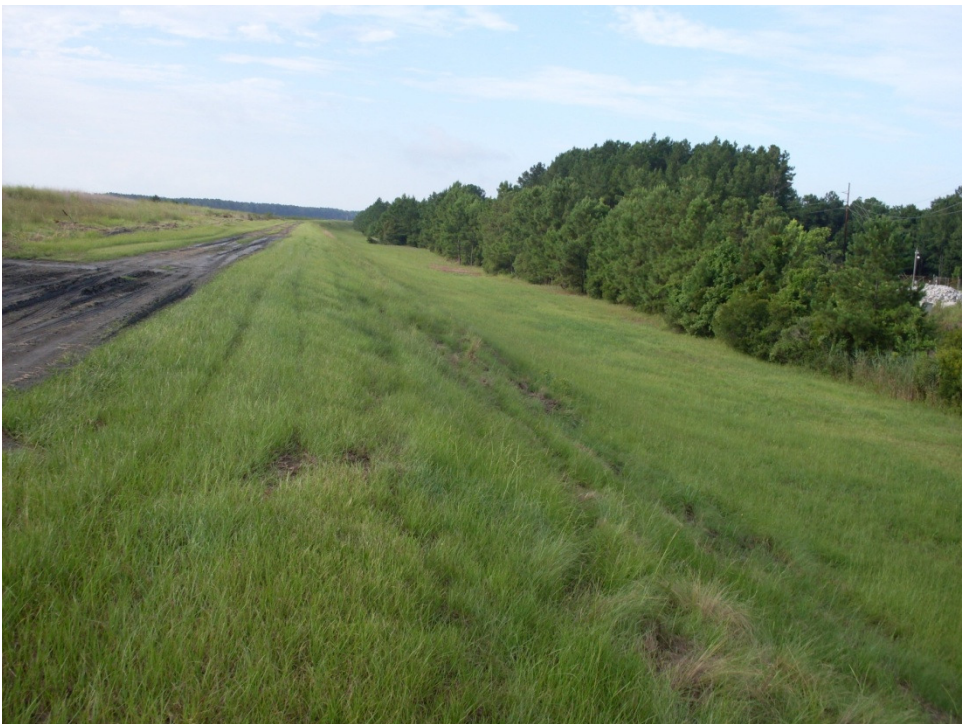
Photo BA-8: Outside Slope of Perimeter Dike West Side of Ash Pond A near a Ash Removal Equipment Access on Ash Pond A – Viewed South.

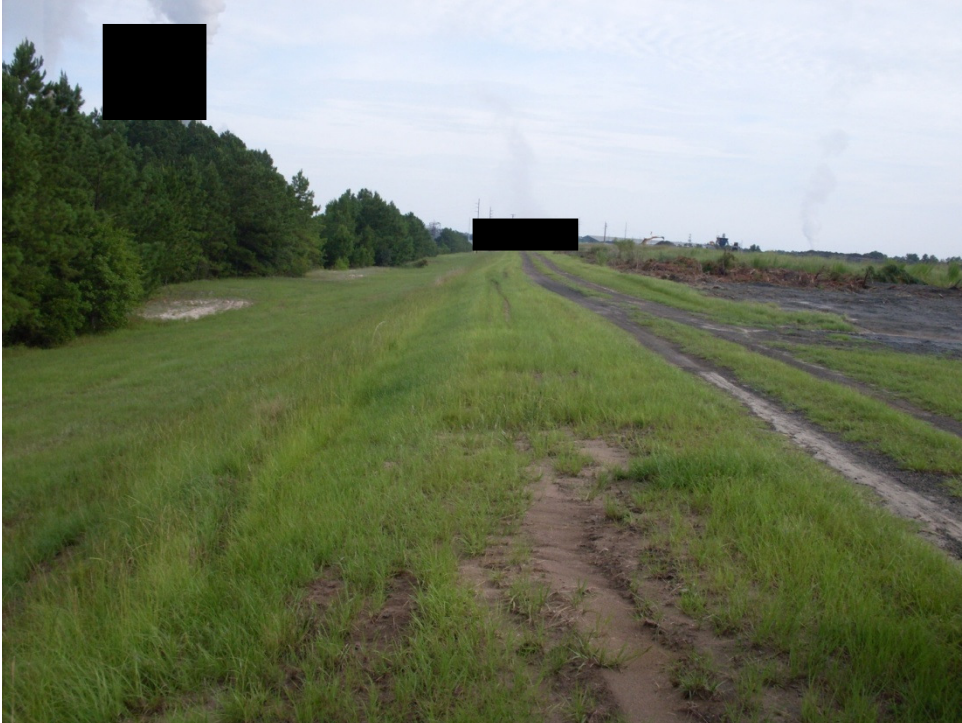
Photo BA-9: Outside Slope of Perimeter Dike at Cross Dike Intersection.

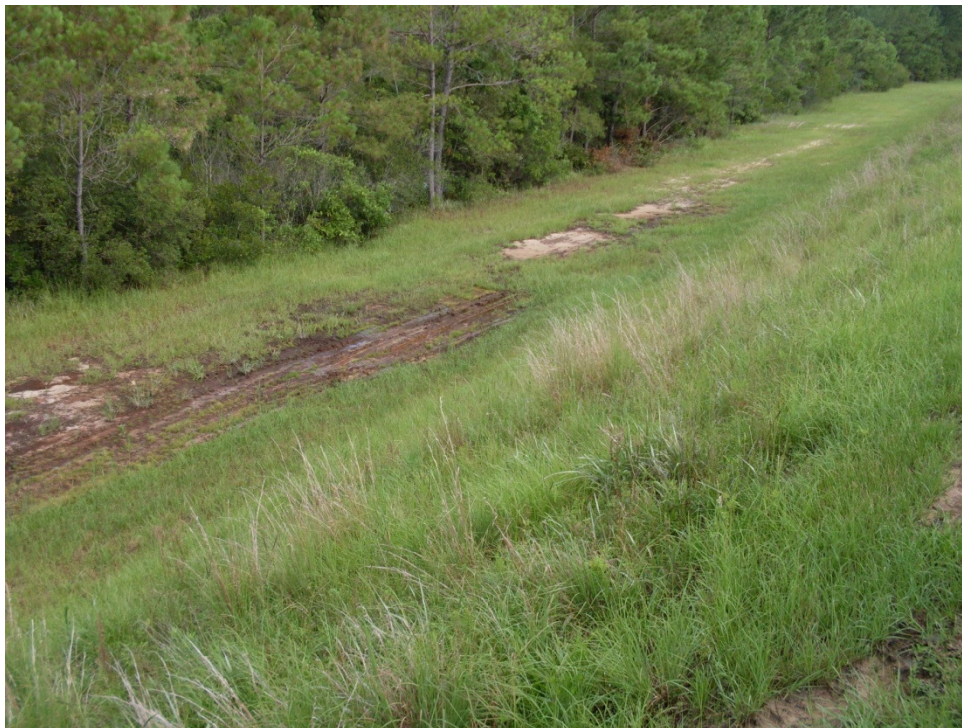
Photo BA-10: Outside Toe of Perimeter Dike at Cross Dike Intersection.

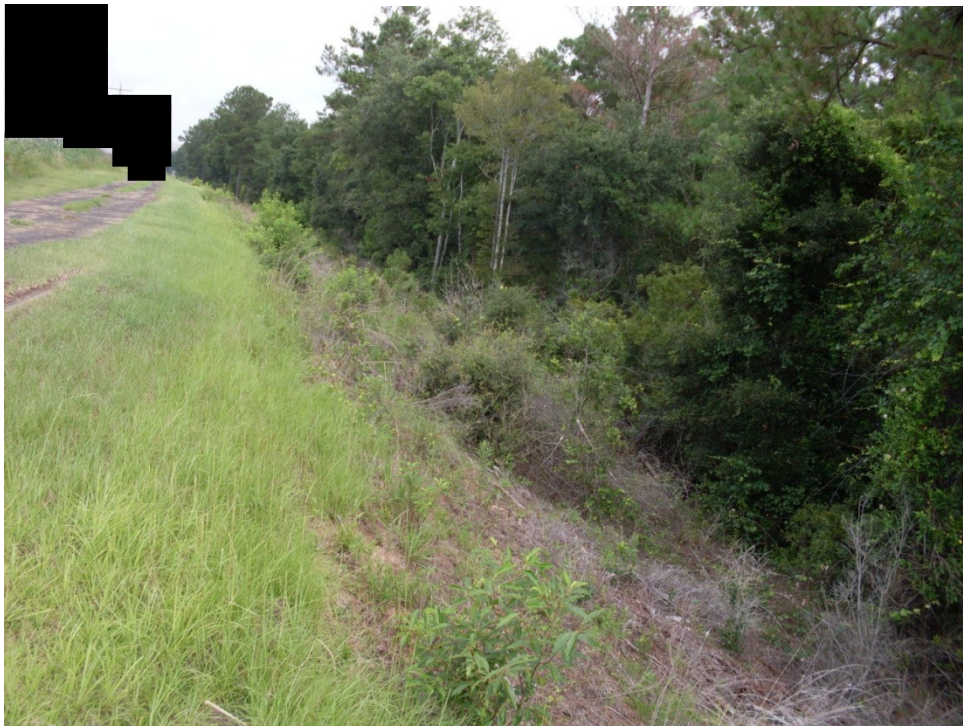
Photo BA-11: Outside Slope of Perimeter Dike North Side of Ash Pond A
at Northeast Corner – Viewed West.

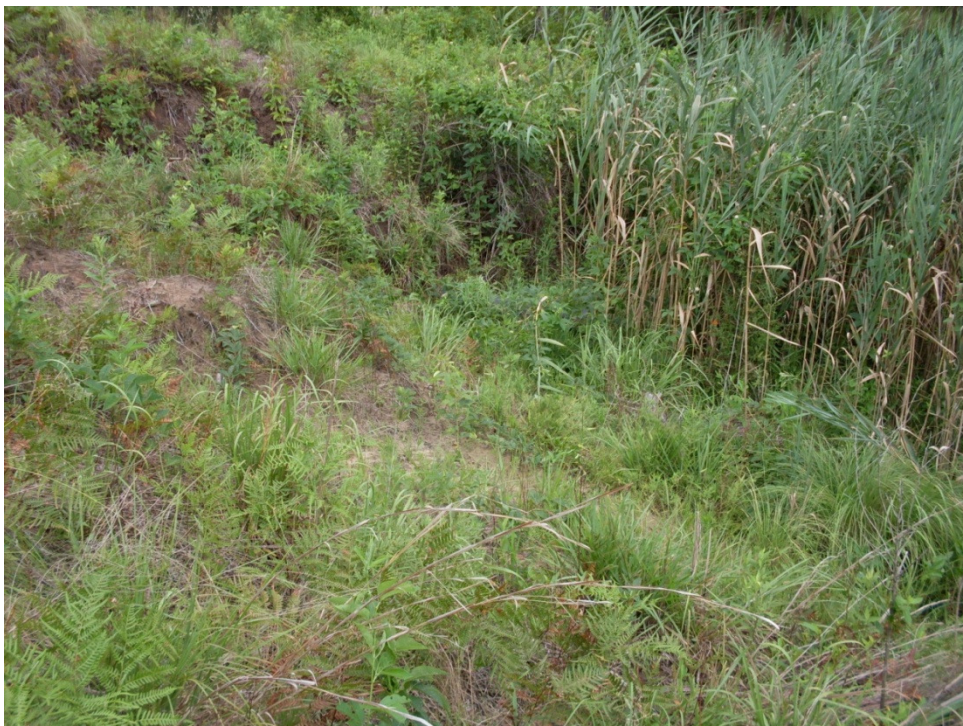
Photo BA-12: Toe of Perimeter Dike North Side of Ash Pond A.

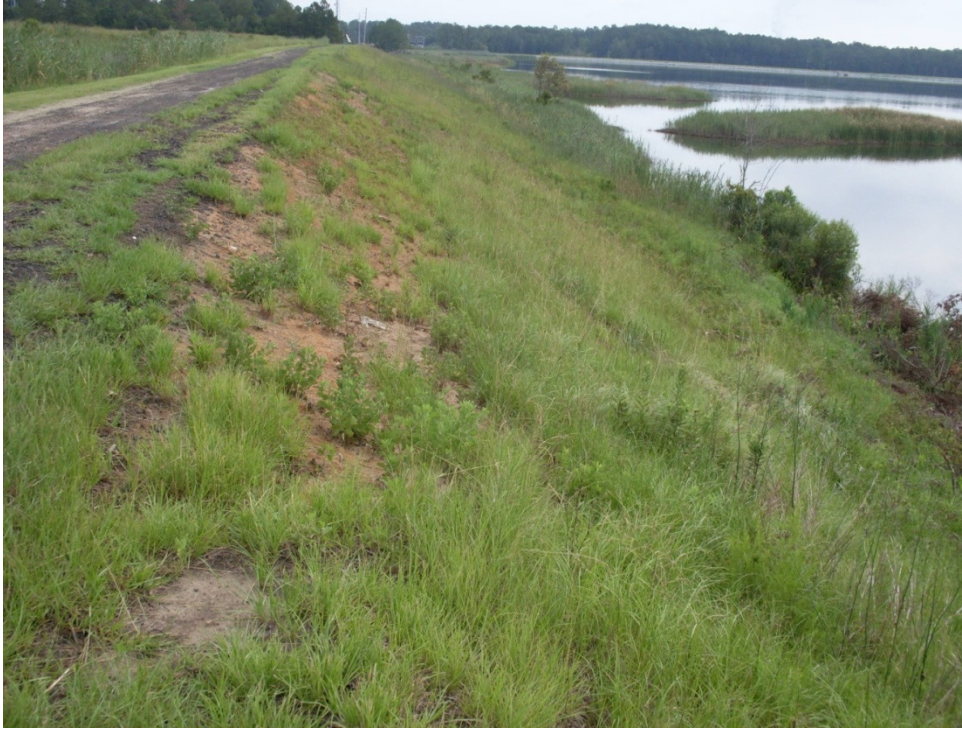
Photo BA-13: Outside Slope of Perimeter Dike East Side of Ash Pond A Near Cross Dike Intersection – Viewed North (Cooling Pond to Right).

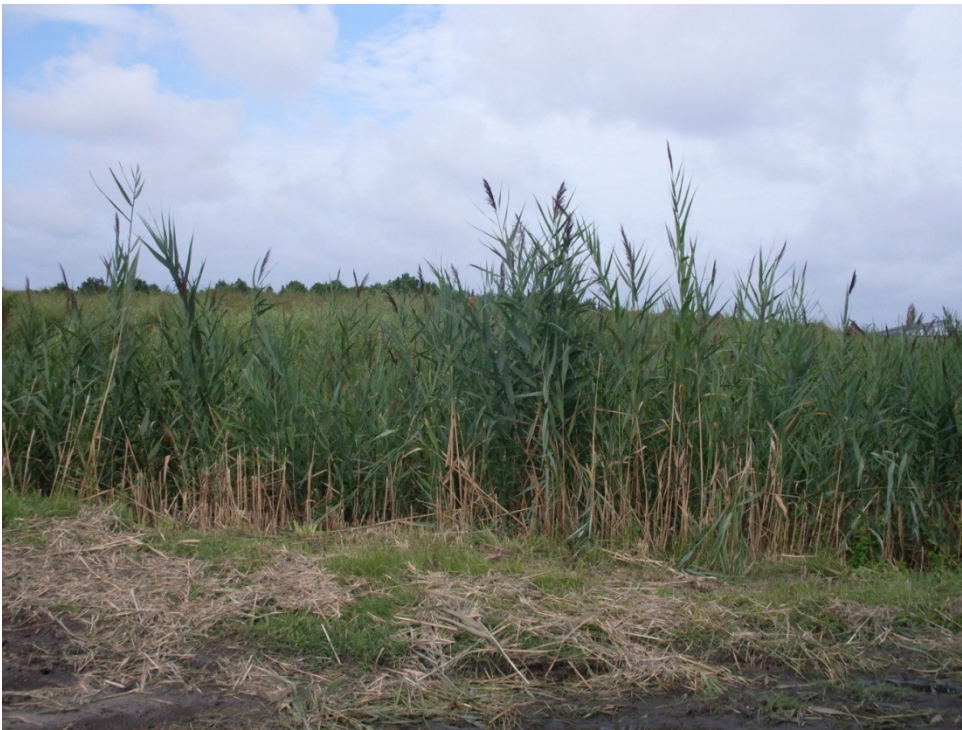
Photo BA-14: Tall Vegetation on Inside of Perimeter Dike North Side of Ash Pond A – Viewed South (Typical View Where Ash Is Not Being Placed or Mined).

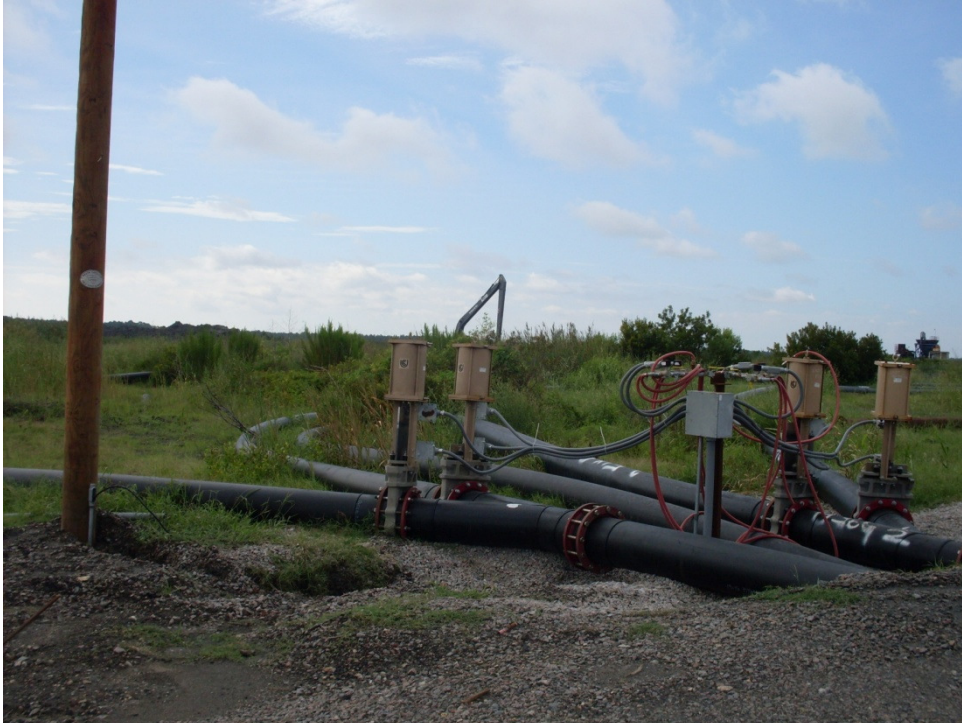
Photo BA-15: Ash Sluice Lines Outside Ash Pond A at Northwest Corner

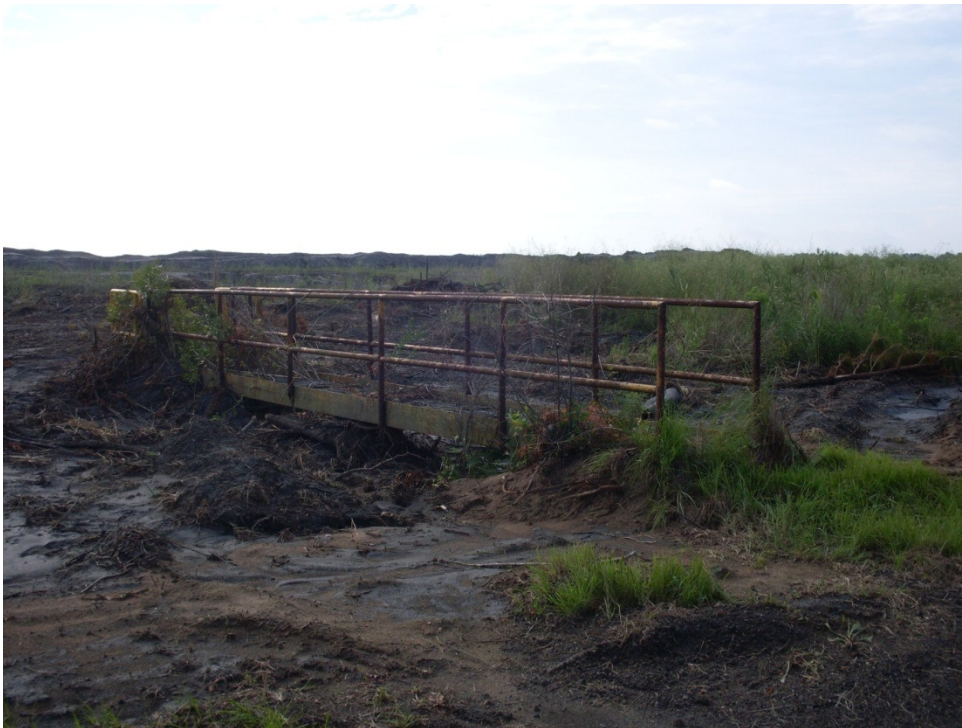
Photo BA-16: Location of Abandoned Decant Tower and CMP Outfall in Ash Pond A that Extends Through West Dike (See Associated Photos BA-13, - 14, and -15).

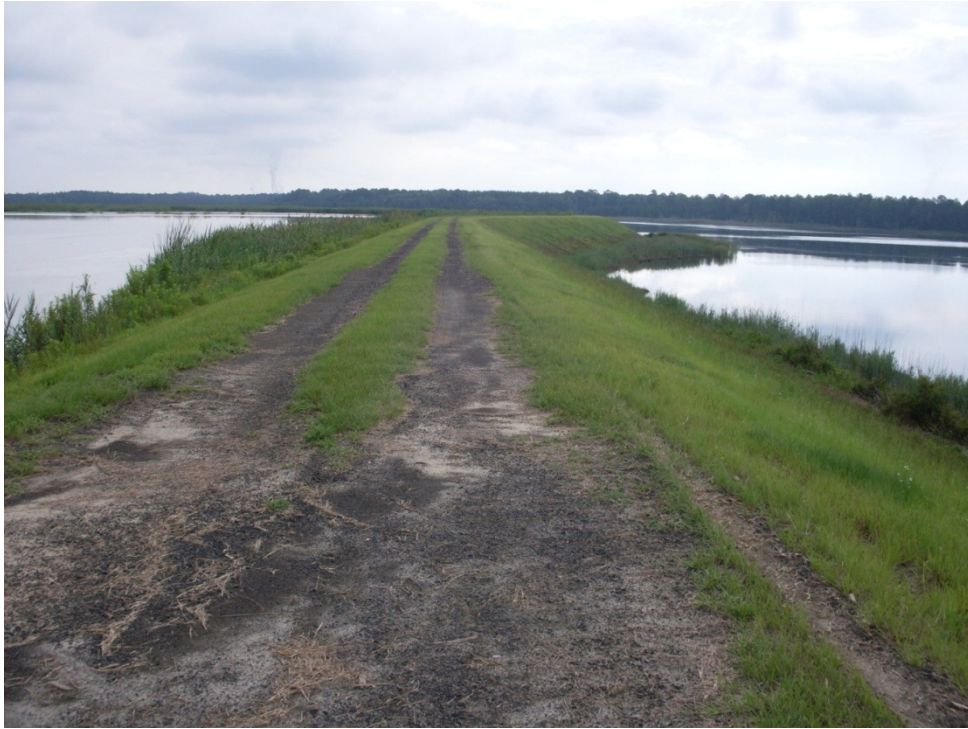
Photo BB-2: Crest of Perimeter Dike South Side of Pond B near South Corner – Viewed Northeast (Cooling Pond to the Right).

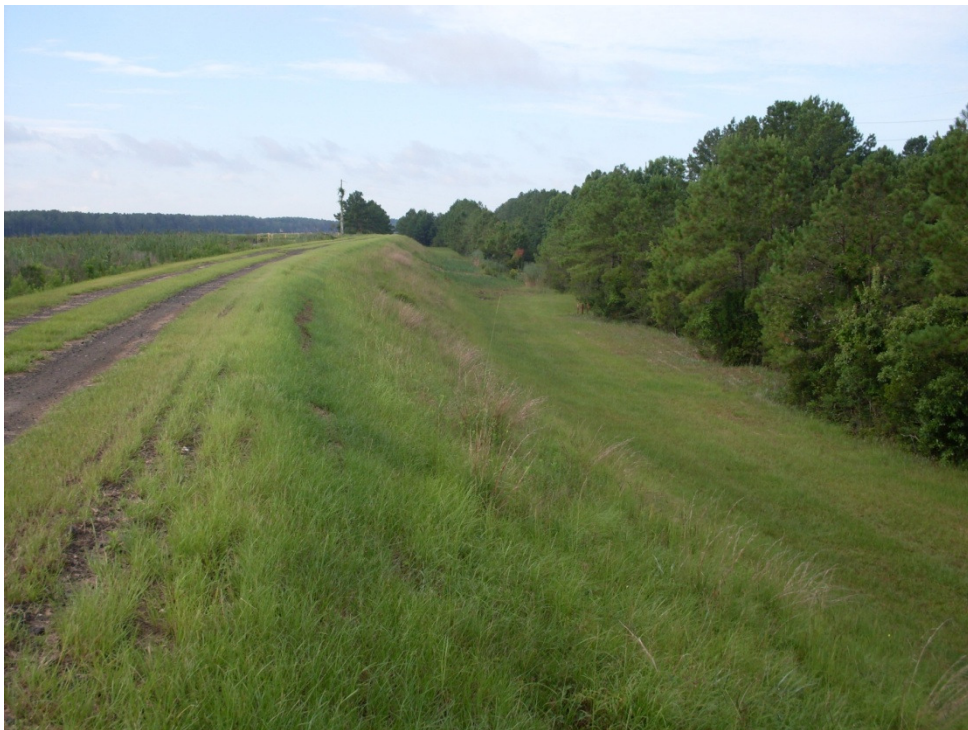
Photo BB-3: Outside Slope of Perimeter Dike West Side of Ash Pond B at Cross Dike Intersection – Viewed South.

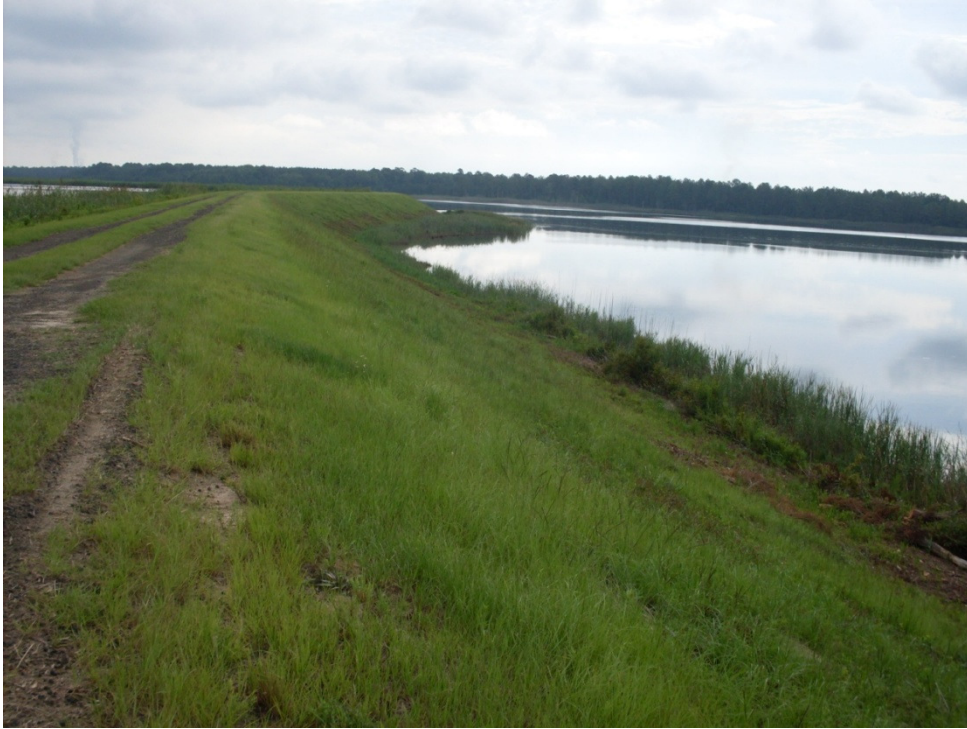
Photo BB-4: Outside Slope of Perimeter Dike South Side of Ash Pond B near South Corner – View Northeast (Cooling Pond to Right).

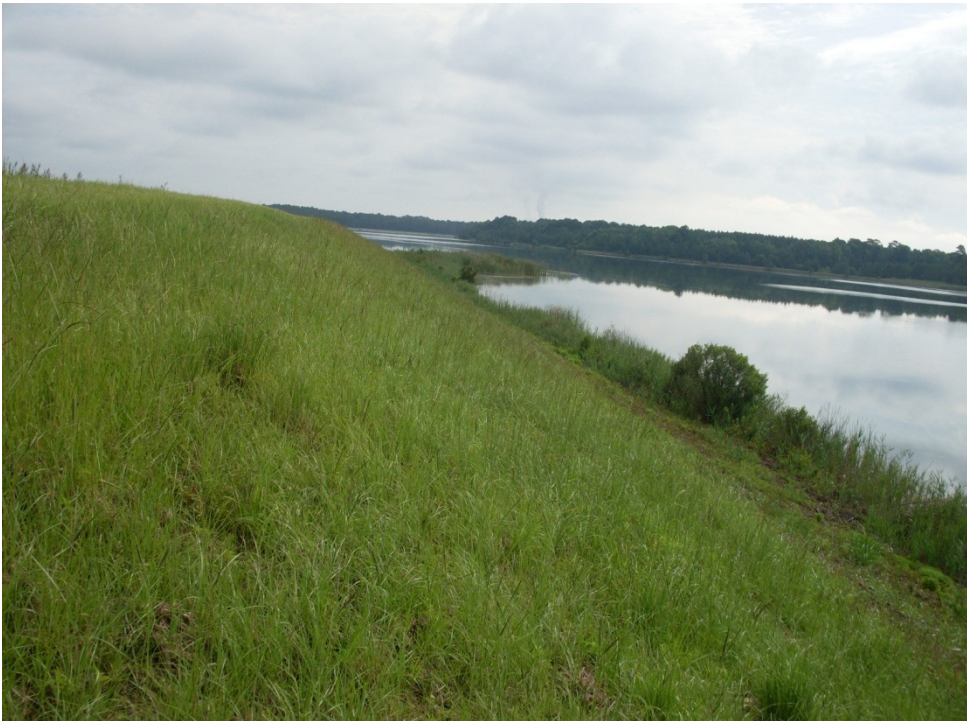
Photo BB-5: Outside Slope of Perimeter Dike near Southeast Corner - Viewed Northeast (Cooling Pond to Right).

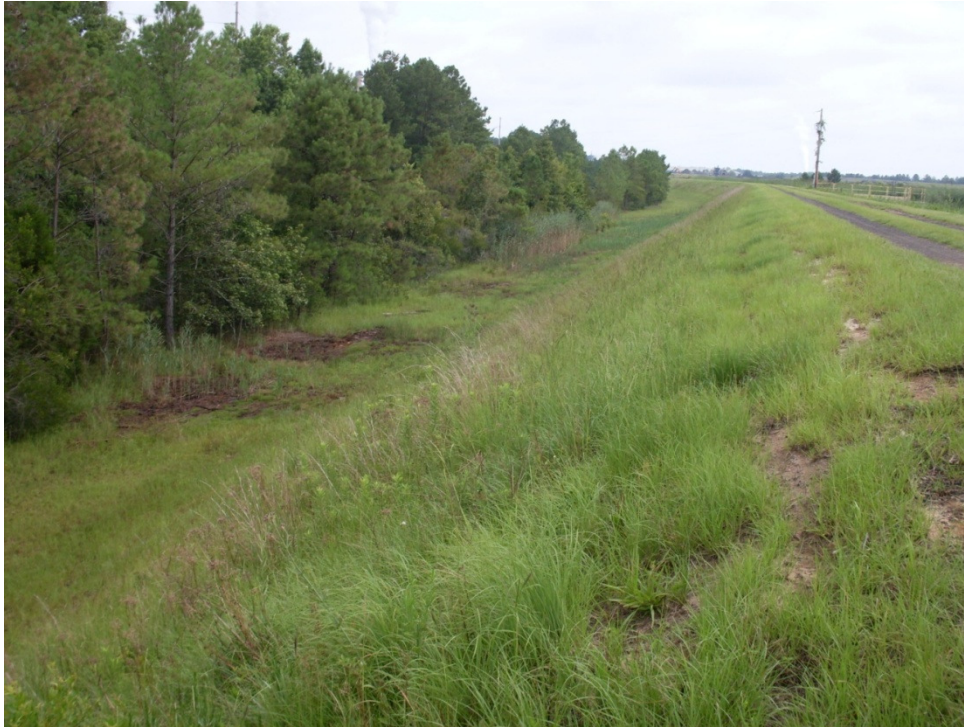
Photo BB-6: Outside Slope and Toe of Perimeter Dike West Side of Ash Pond B near South Corner –Viewed North (Note Wet Area At Toe).

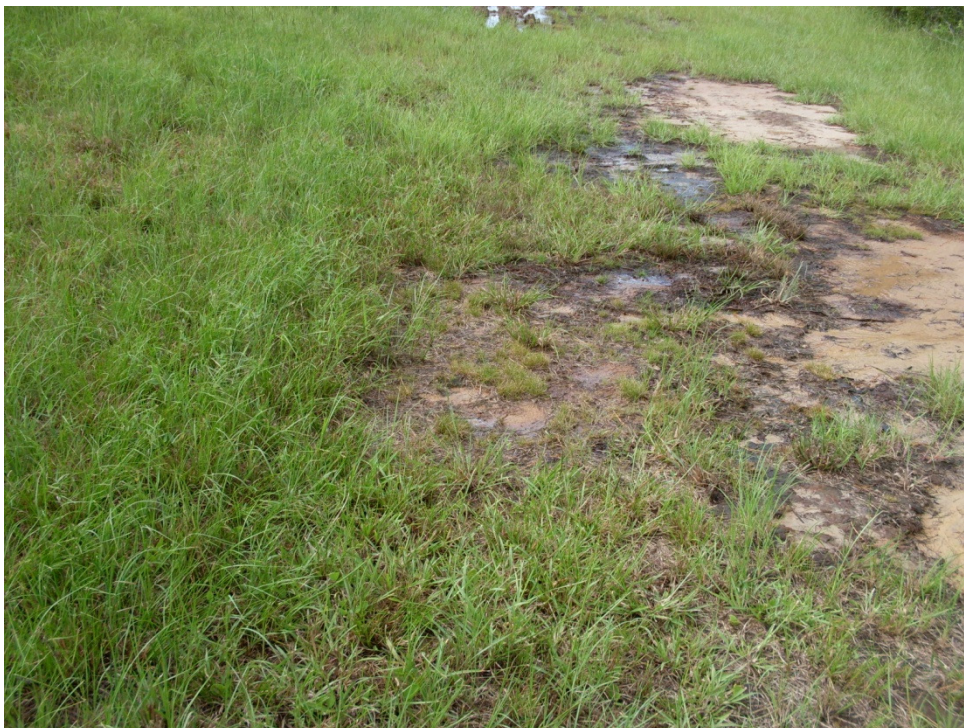
Photo BB-7: Closer View of North Part of Wet Area Shown in Previous Photo.

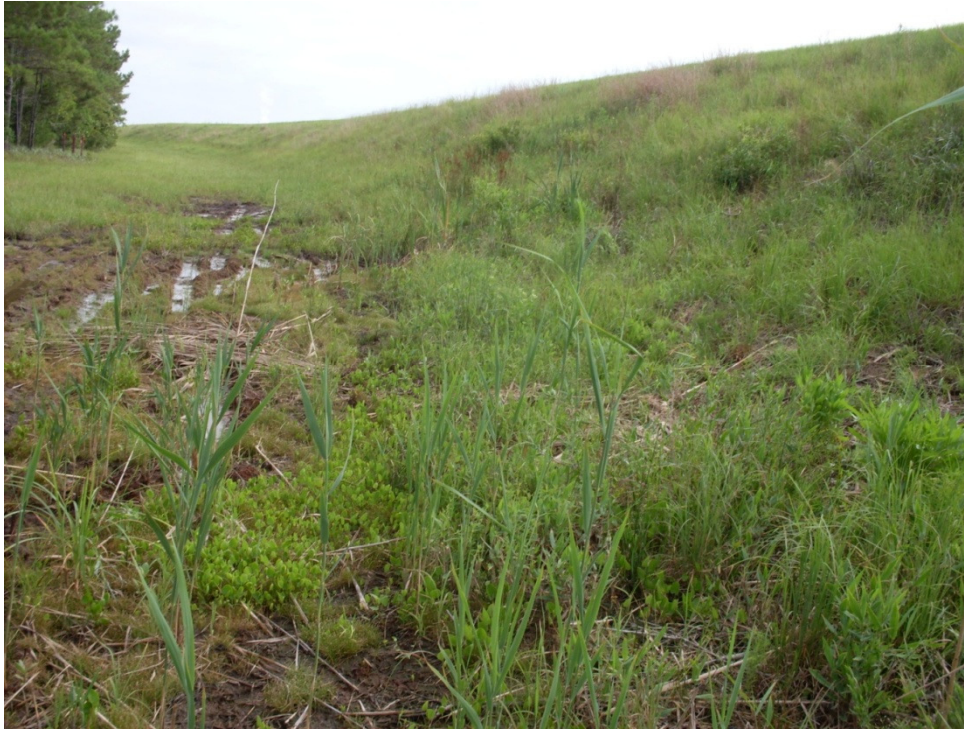
Photo BB-8: Outside Toe of Perimeter Dike West Side of Ash Pond B Decant Tower North of Buried Outfall Drain Pipe – View North.

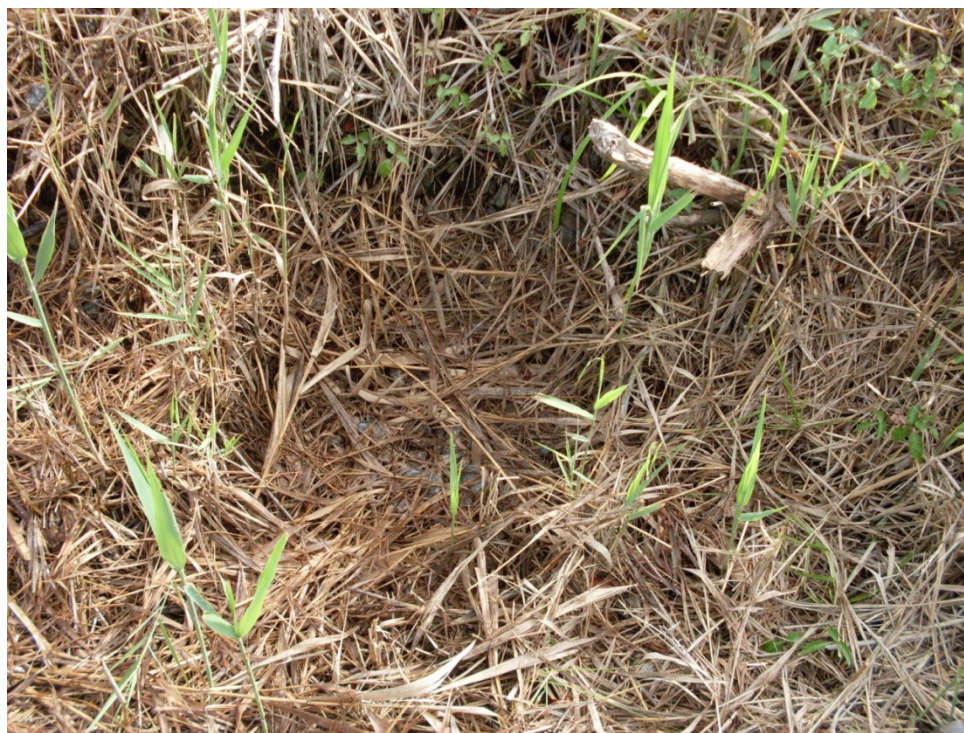
Photo BB-9: Depression and Exposed Gravel (Under Grass) Upstream of Ash Pond B Drain Outfall. (Apparent Separation at Last Joint in RCP).

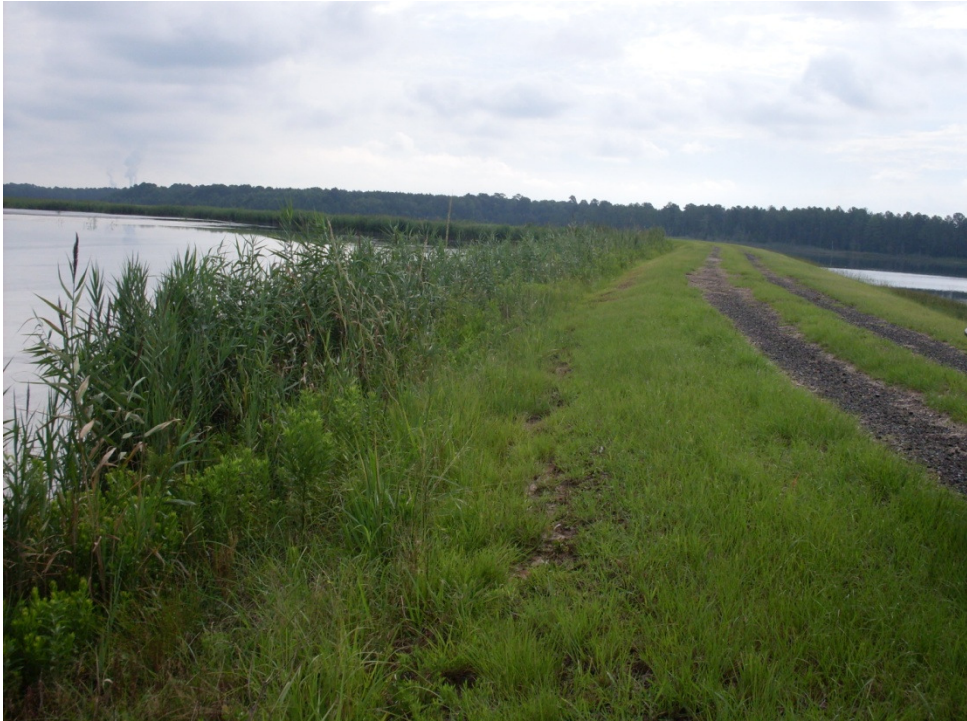
Photo BB-10: Inside Slope of Perimeter Dike East Side of Ash Pond B Near Southeast Bend – Viewed Northeast. (Cooling Pond to Right)

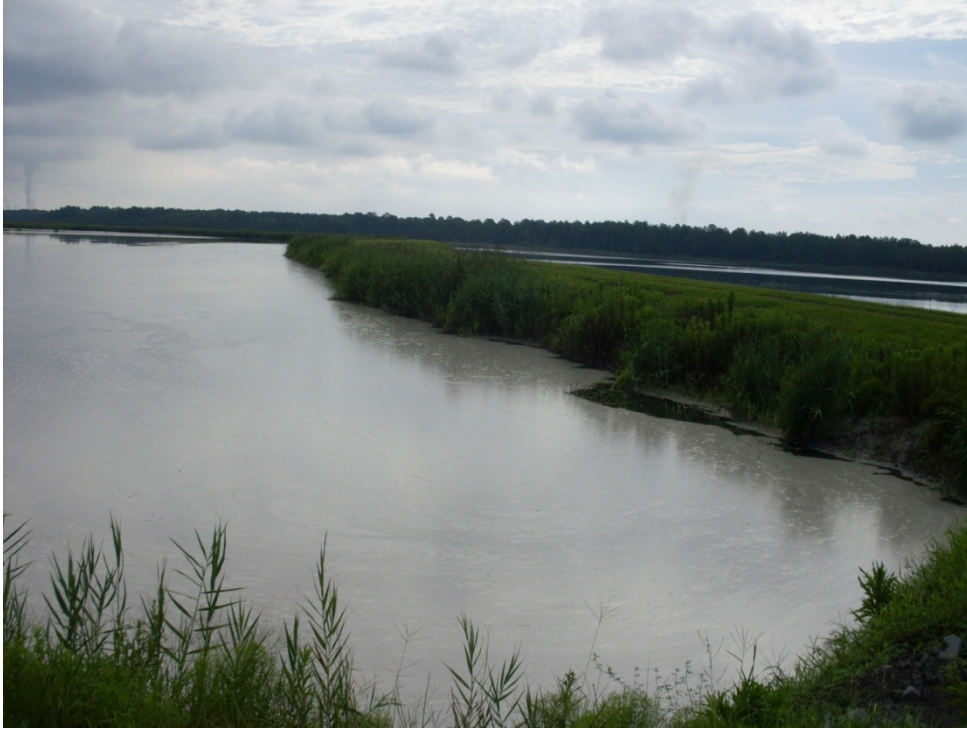
Photo BB-12: Inside Slope of Perimeter Dike South Side of Ash Pond B at South Corner – Viewed Northeast.

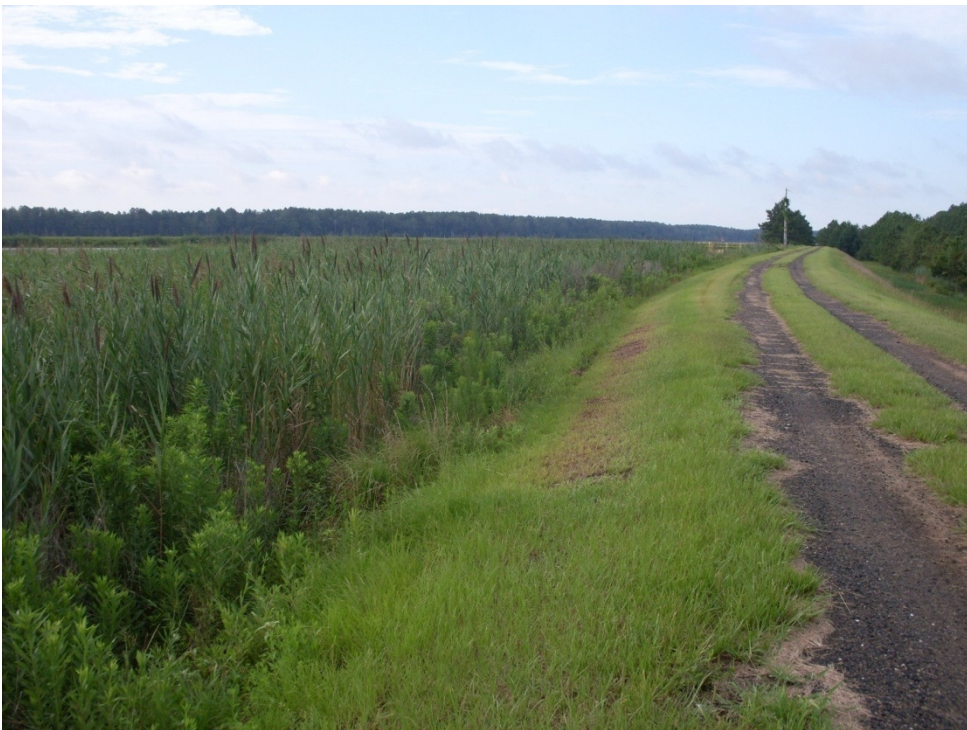
Photo BB-13: Inside Slope of Perimeter Dike West Side of Ash Pond B South of Cross Dike Intersection – Viewed South.

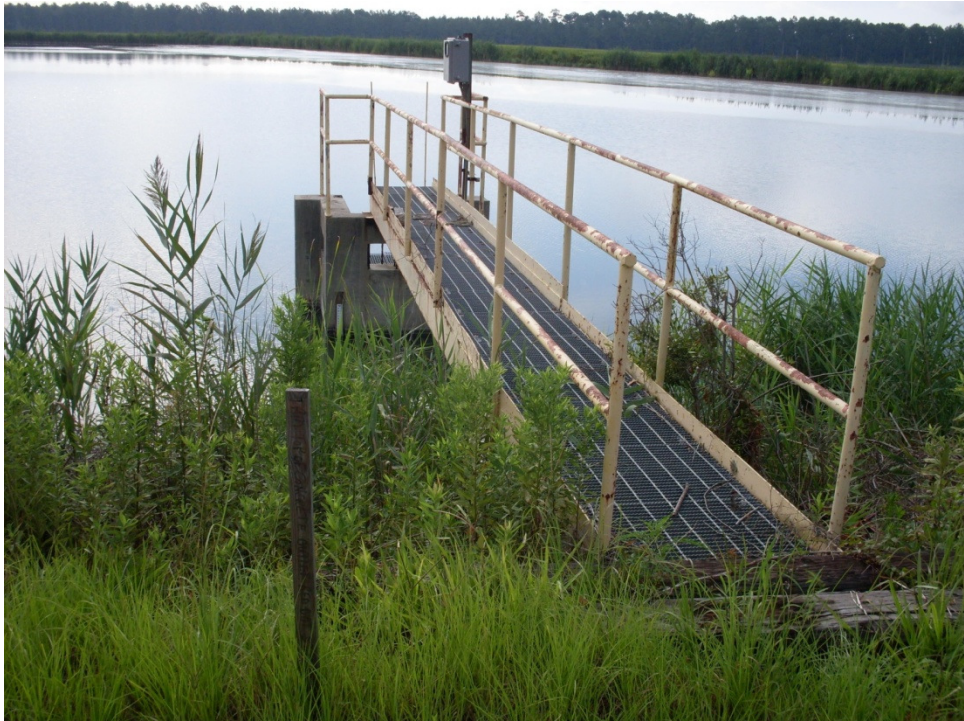
Photo BB-14: View of North and East Side of Ash Pond B Decant Tower.

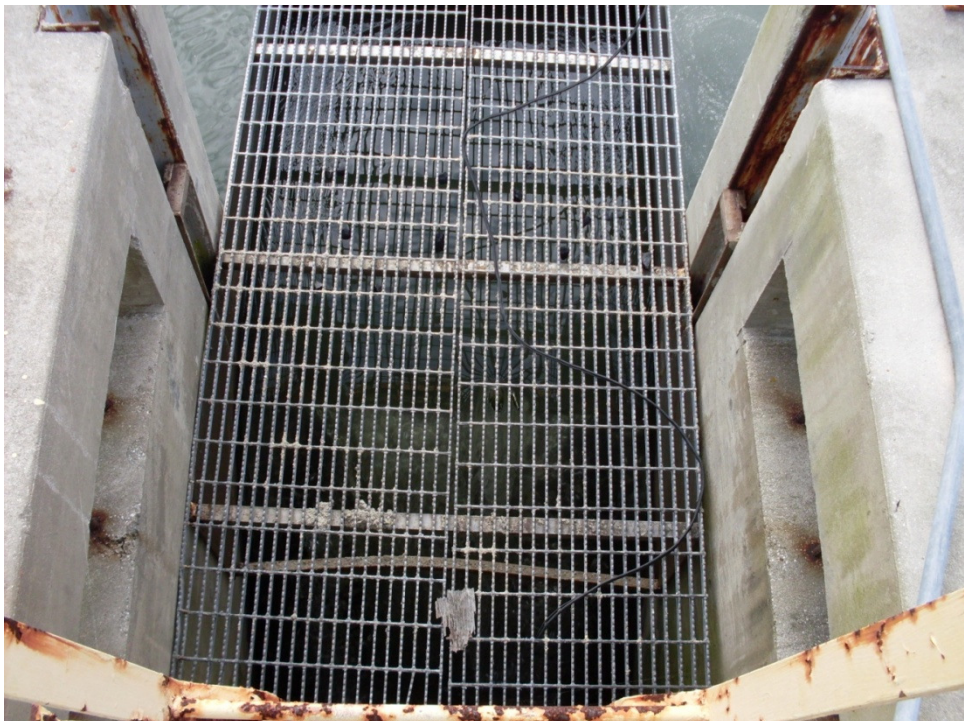
Photo BB-15: View Through Top Grate of Ash Pond B Decant Tower.

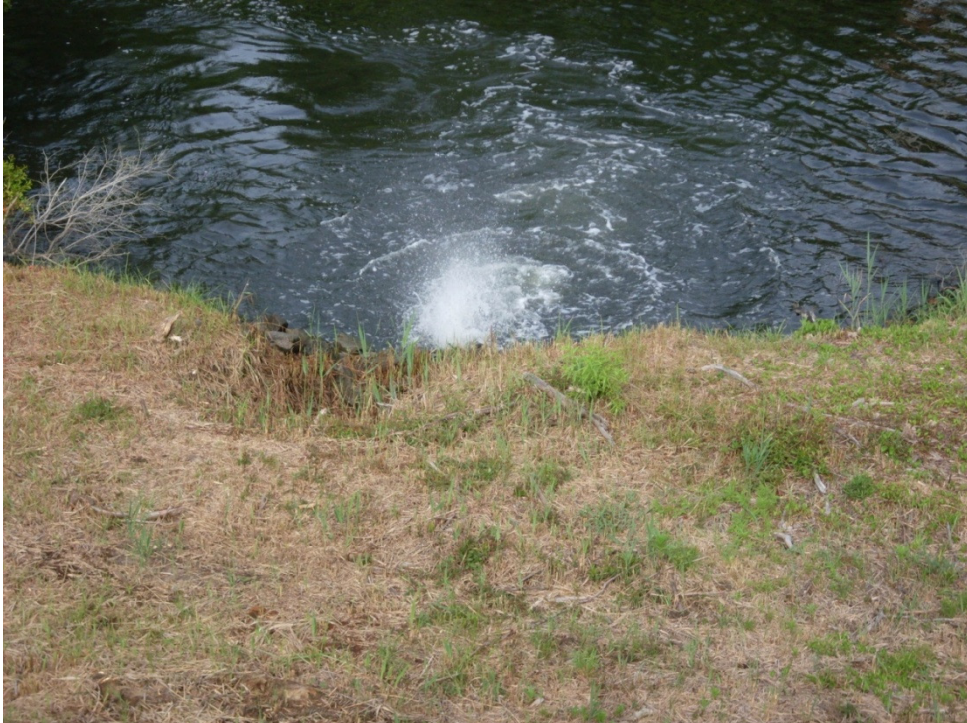
Photo BB-16: View Downstream Along RCP Outfall Pipe of Ash Pond B Decant Tower. (Note “blow” of discharge from partially submerged outlet due to entrapped air.).

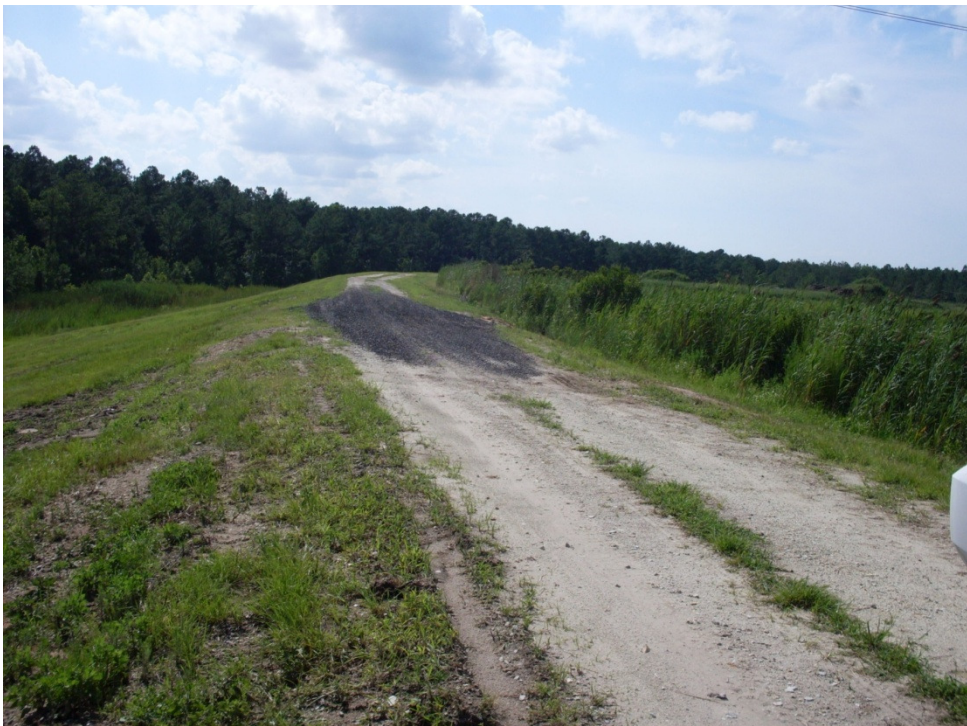
Photo BS-1: Crest and Outside Slope of Perimeter Dike at Southwest Bend of South Ash Pond – Viewed West.

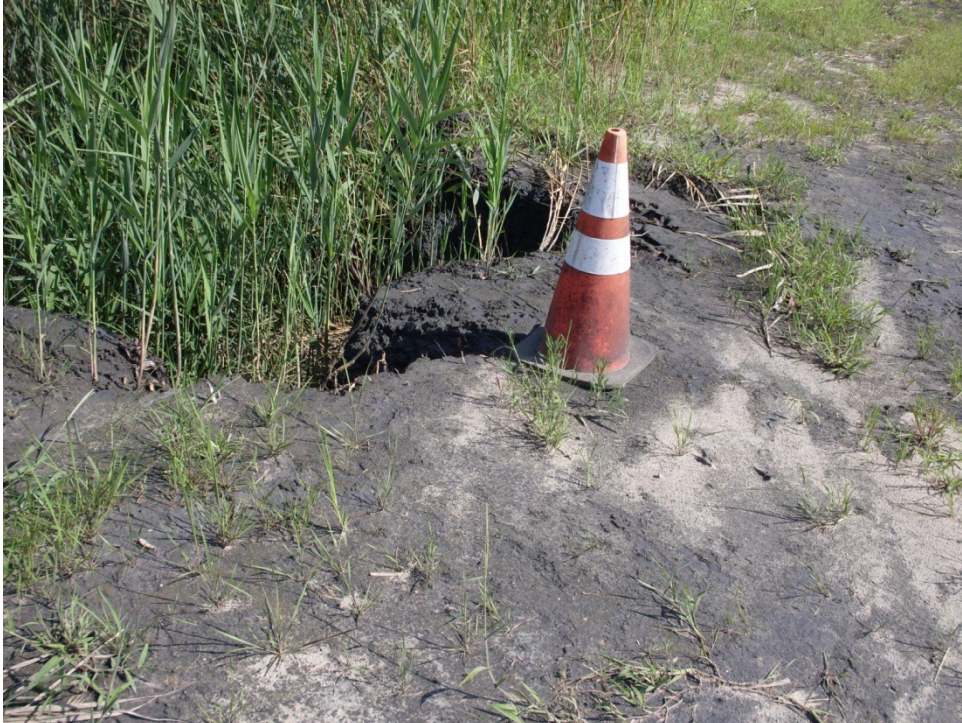
Photo BS-2: Ash Washout Adjacent to Crest of Perimeter Dike of South Ash Pond at Western End.
